DISC-E-95GP-0301

REPORT OF FINDINGS: ENGINEERING PRACTICES STUDY ON FAILURE ANALYSIS OF
NSN 5340-00-136-9872 GROOVED COUPLING CLAMP

Bohdan Hasiuk
Defense Industrial Supply Center
DISC-ECM
700 Robbins Avenue
Philadelphia, PA 19111-5096

3 October 1988

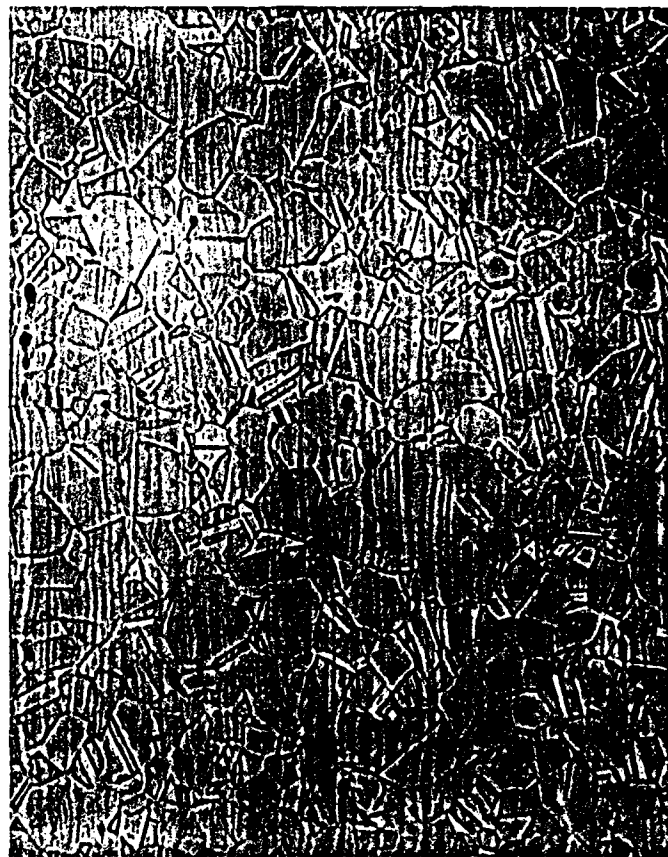
Figure 1C - 500X. Same as figure 1B, only higher magnification. Note the spherical shape of the non-metallic inclusions (probably cross-sections of the stringers from figures 1 and 1A).

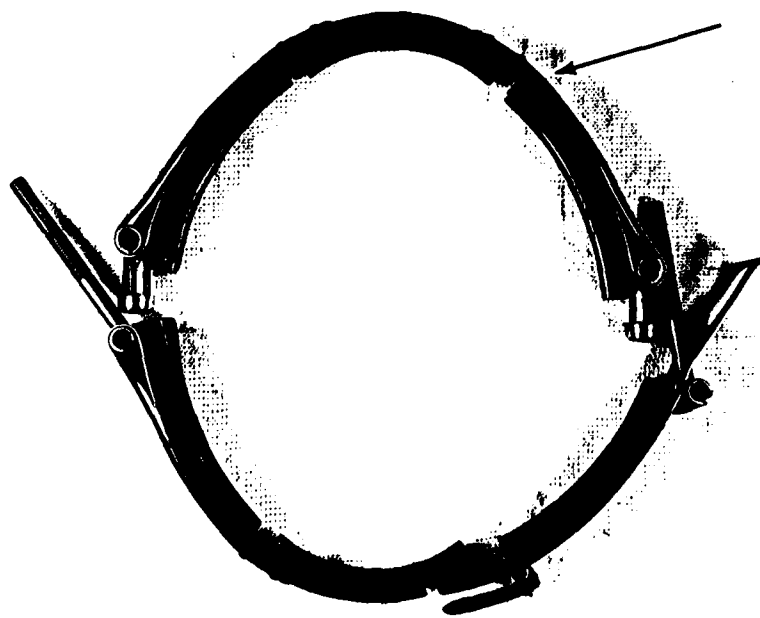
Figure 2A - 0.4X. The as-received V-Band coupling clamp. The arrow indicates the rivet area of the clamp where a crack was found. The area of the crack is shown in more detail in figure 2B.

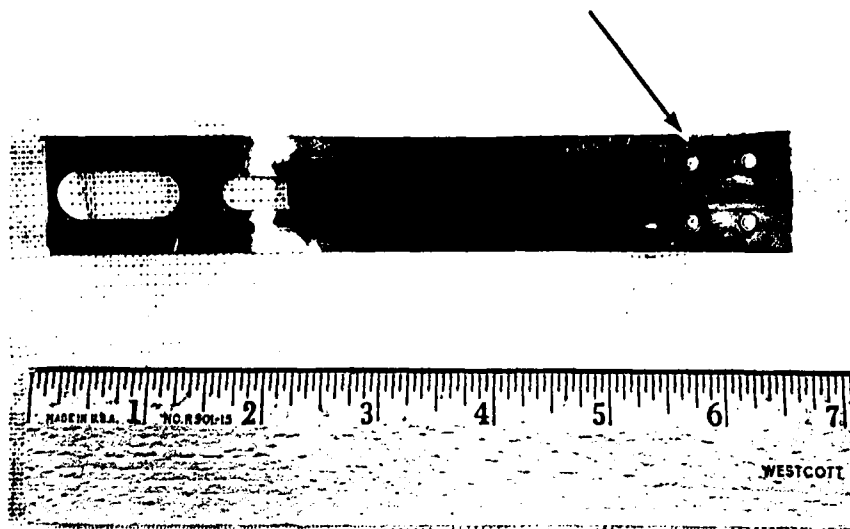
A section of the clamp containing the crack was cut out and is shown in figure 2B (with the arrow pointing to the crack). The area containing the crack is shown in more detail in figures 2C through 2E. Examining figures 2C through 2E, the following generalizations can be made:

Figure 2B - 0.63X. Inside surface of the clamp showing the four rivet holes. The arrow points to a crack in the close proximity to one of the rivet holes. The area indicated by the arrow is shown in more detail in figure 2C.

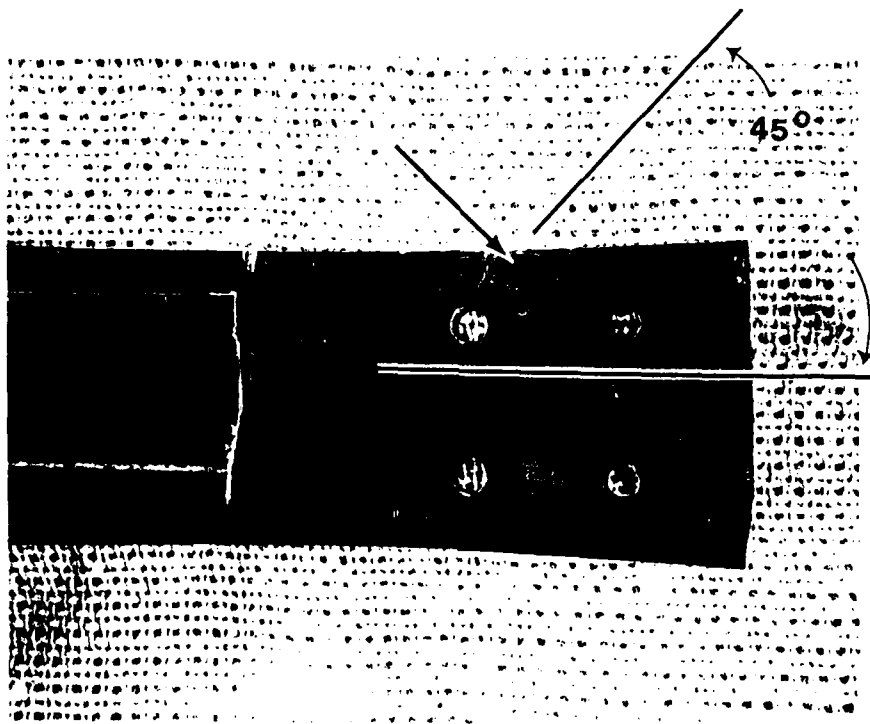
Figure 2C - 1.5X. A more detailed view of the inside surface of the clamp from figure 2B. The arrow points to a crack, which is plainly visible. Note that the crack is at approximately 45° to the circumferential direction (of the clamp). This area is shown in more detail in figure 2D.

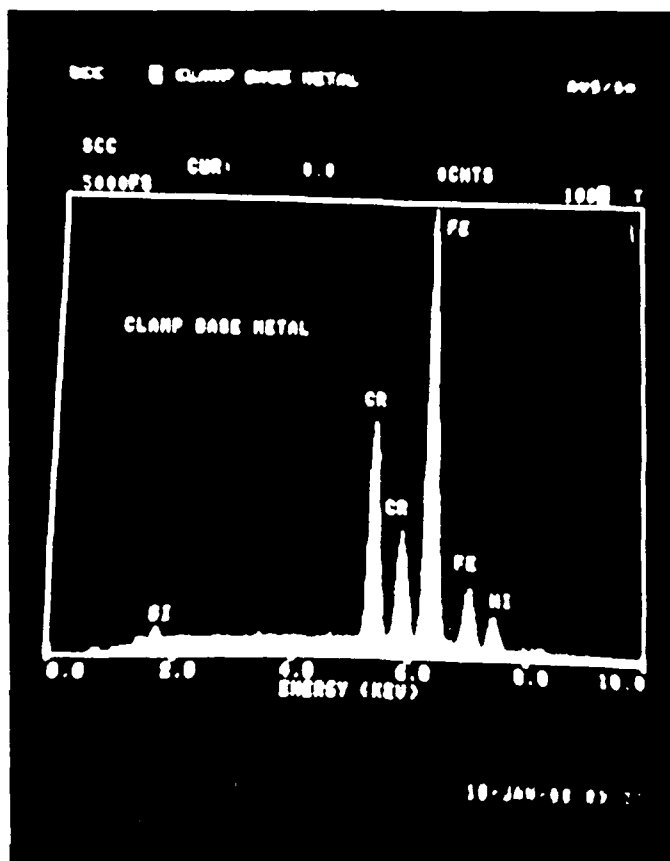
Examining figure 4 it becomes obvious that we are looking at austenitic stainless steel (very strong primary and secondary iron lines as well as significant chromium, nickel and silicon lines). However, when we look at figure 4A, which represents the EDS analysis of the crack surface, we see an extremely strong chloride line and very significant sulfide, potassium and sodium lines. This represents quite a "zoo" of corrodents with the most powerful corrodent, namely chloride, in extremely high concentrations.

Figure 4. Energy Dispersive Spectroscopy (EDS) of the clean (broken in the laboratory) surface showing the basic chemistry of the clamp material (AMS 5595, iron-chromium-nickel alloy).

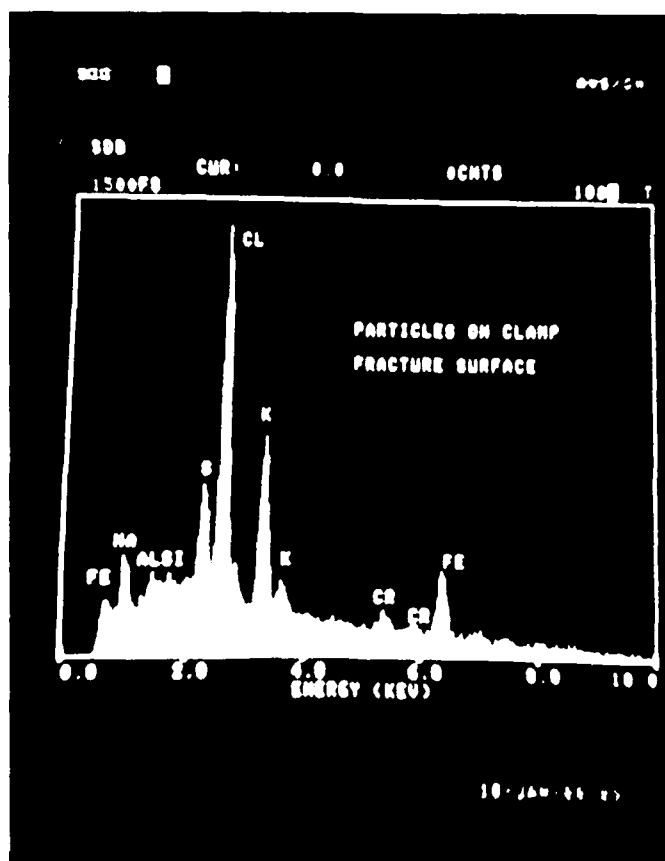
Since the crack originated under the rivet head (crevice attack) and large concentration of sulfur (polythionic acid) and chlorides were found (figure 4A) - all the corrosion conditions for stress corrosion cracking were present.

Figure 4A. Energy Dispersive Spectroscopy (EDS) of the particles found on the surface of the opened crack ("A" crack of figures 2D and 2E). Note the relatively high concentrations of chlorides and sulfides.
